**CANADIAN FORCES
FLIGHT SAFETY INVESTIGATION REPORT (FSIR)**

FINAL REPORT

FILE NUMBER: 1010-C-GFMC (DFS 2-3-3)
DATE OF REPORT: 25 July 2006

AIRCRAFT TYPE: SGS-2-33A C-GFMC
DATE/TIME: 01 2205Z May 2005
LOCATION: Netook Gliding Centre (Olds, Alberta)
CATEGORY: "B" Category Accident

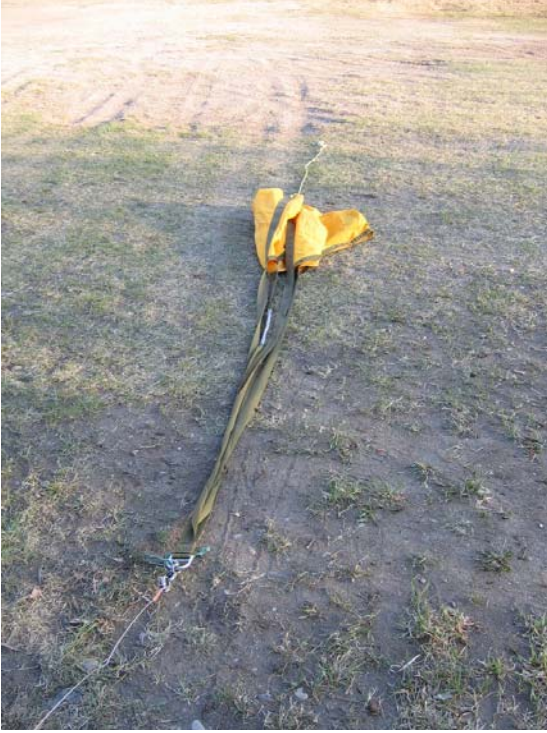
Photograph 3: Cable, Chute, Weak Link

The tow-rope consists of three main sections. The first section is a 4,400 foot long steel cable. This is attached on one end to the winch, and on the other to a drogue parachute. The drogue parachute, which is designed to deploy only after tension has been released from the tow-rope, is used to slow the descent of the cable after it has been released from the glider. The parachute is then attached to a "weak-link". The weak-link is a length of rope designed to break under a pre-determined stress load in the event the glider cannot release the tow-rope. The weak-link is then attached to the glider. (Photo 3)

4.1.4. Prairie Region Air Cadets is trialling a 25 foot weak link for the 2006 gliding season.
